## Moody Towers, University of Houston

CASE STUDY

### Potential Water Crisis Averted – CuraFlo® Revitalizes Dormitory Piping at University of Houston

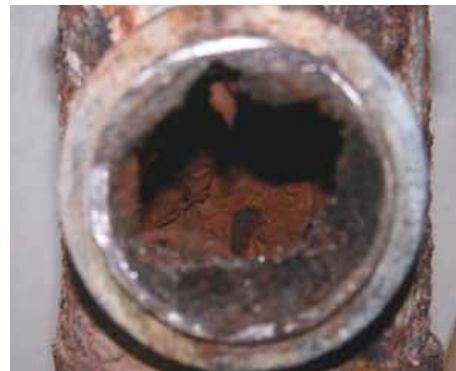
*Tuberculation or build-up of scale inside a galvanized pipe reduces internal pipe diameter, consequently affecting water flow and water pressure*

LeMaire and Turner recommended a combination of epoxy lining and pipe replacement in areas where existing pipe was too eroded to line. Their recommendation ensured a sturdy, long-lasting solution for the towers – and a quick turnaround to meet UH's strict timetable.

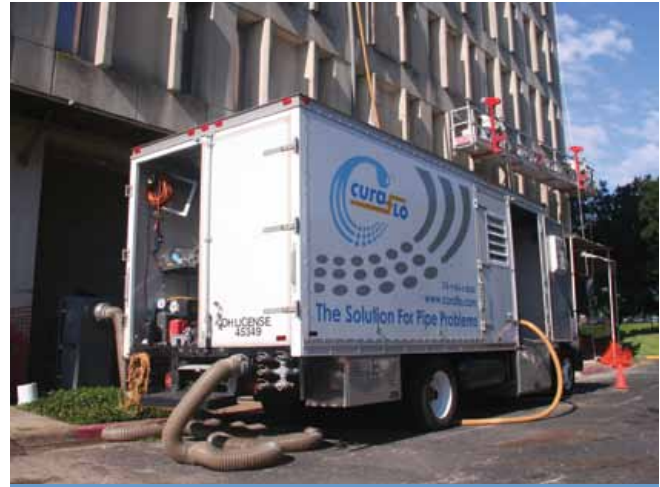
*CuraFlo uses state-of-the-art equipment to complete lining projects as effectively and quietly as possible.*

Workers then dried the pipes with pressurized hot air. Next, pipe interiors were "sandblasted" with specialized particles to remove all debris and mineral build-up and prepare the internal surface of the water pipe for bonding with the epoxy. From there, workers flowed epoxy into and through all pits, crevices, pinholes and fractures, bonding it to the cleaned and prepared walls of the pipes and creating a seamless, permanent, protective barrier. The inside of the pipes were coated with CuraPoxy at an average thickness of 16 mils. After the coating cured, a pressure test was applied at 120 psi to assure a leak-free system.
